# Non-destructive inspection in industrial equipment using robotic mobile manipulation

**Abstract.** MAINBOT project has developed service robots based applications to autonomously execute inspection tasks in extensive industrial plants in equipment that is arranged horizontally (using ground robots) or vertically (climbing robots). The industrial objective has been to provide a means to help measuring several physical parameters in multiple points by autonomous robots, able to navigate and climb structures, handling non-destructive testing sensors. MAINBOT has validated the solutions in two solar thermal plants (cylindrical-parabolic collectors and central tower), that are very demanding from mobile manipulation point of view mainly due to the extension (e.g. a thermal solar plant of 50Mw, with 400 hectares, 400.000 mirrors, 180 km of absorber tubes, 140m height tower), the variability of conditions (outdoor, day-night), safety requirements, etc. Once the technology was validated in simulation, the system was deployed in real setups and different validation tests carried out. In this paper two of the achievements related with the ground mobile inspection system are presented: (1)

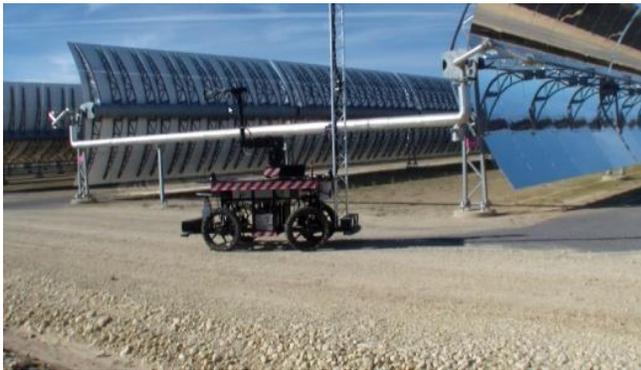
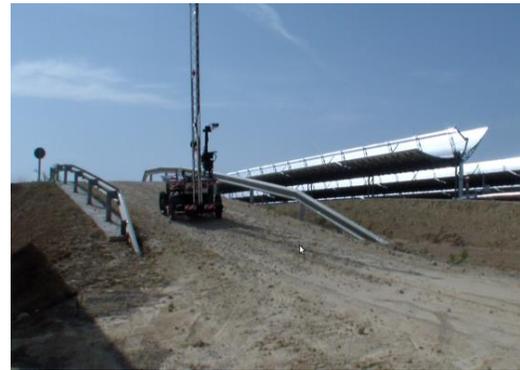
**FIGURE 2.** Robot navigating from one loop to another (a) and navigating in the plant (b)

- Transition from one loop exit to the adjacent loop entrance. During the transition from one loop to another the robot must move through an unpaved road
- Navigation through the solar plant It includes the transition from one terrace to another, i.e. climbing steep slopes through an irregular terrain, crossing bridges as in the picture below, etc.
- Taxing from the robot park area to the solar field (to the nearest loop entrance). It includes some paved paths

The platform had to navigate autonomously five times in each area, trying to reach a target position, meanwhile all data available was recorded for offline analysis of the error in X, Y position, the Yaw error and the time difference with the theoretical value.

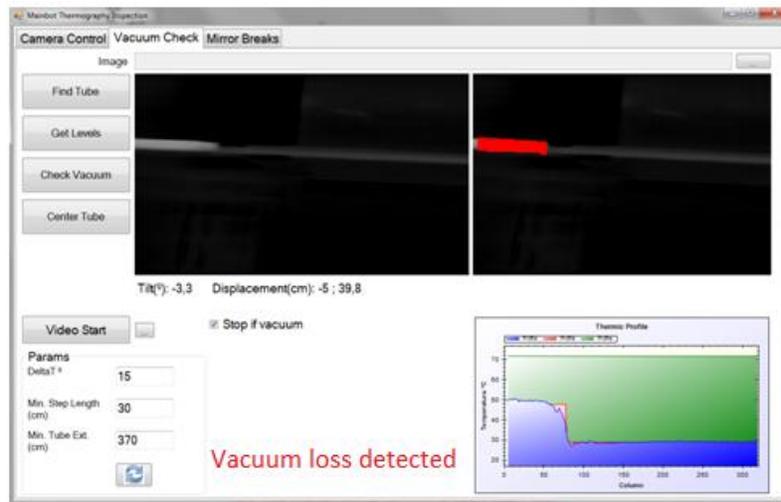
**FIGURE 3.** Application developed for vacuum loss detection

The previous picture, shows the application developed to automatically identify the vacuum loss, the thermal image, the area with the problem and the gradient of temperature.

The algorithm detected all of the vacuum losses present without giving false positives or false negatives, obtaining a detection ratio of 100%.
